APPENDIX B: Bridge Inspection Guidance

Preliminary Bat Inspection Guidelines for Bridges/Structures

DOT Environmental Division

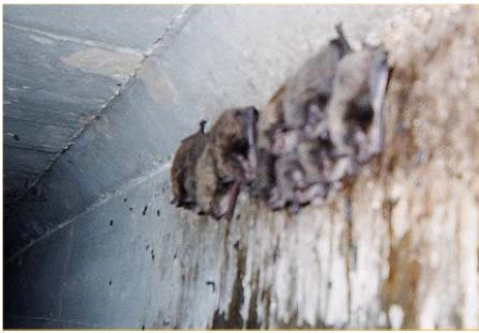
Photo 1: Bats hanging from cracks along Support beams

Cracks in the concrete are used by bats as a foothold in roosting (Photo 1). In addition, some bats may be hidden from sight in wider cracks in the concrete and behind deteriorating concrete sections in the ceiling or walls. Look for cracking along support beams and inner walls especially below a fillet (a concrete filling between ceiling and vertical beam). During inspection, sounds may be heard coming from behind such cracks and/or expansion joints.

Look for bats flying or roosting (hanging) during inspection (Photo 1, 2, & 8). A flashlight or headlamp will be needed and binoculars may be necessary when viewing higher areas. If bats are present; record numbers as best as possible and their locations. Note any dead or injured bats. A sketch map would be helpful (can use bridge plan sheet as base for sketch).

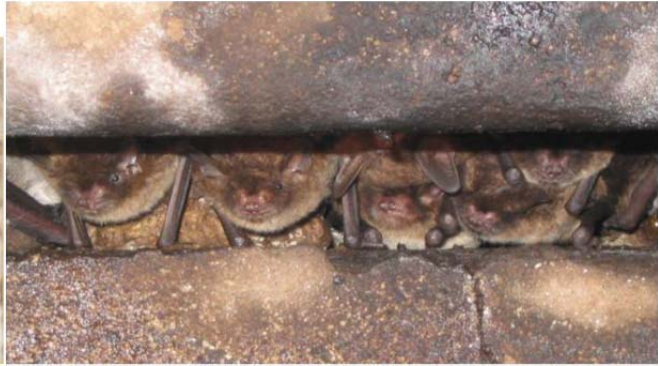
Photo 2: Visible bats within an expansion joint

Expansion joints can provide protected cover for bats (Photos 2 and 3), but do not always provide habitat, depending upon whether they are obstructed by road debris or other blockages to use. If possible during inspection, individuals should look into expansion joints or in other cracks with a flashlight. If joints are used by bats, often there will be guano under the joints (Photos 4-6), but not always, since the joint may be located over water.

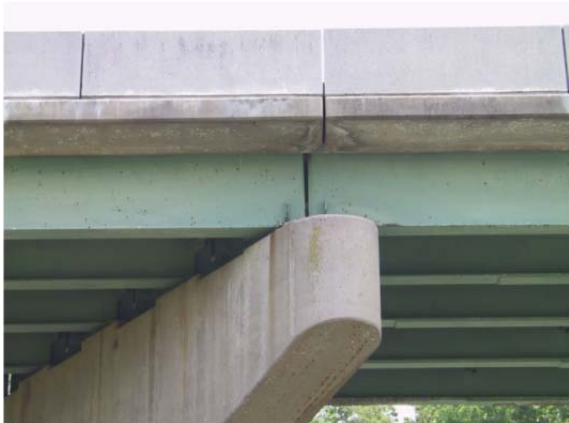
Photo 3: Example of open concrete joint used by bats

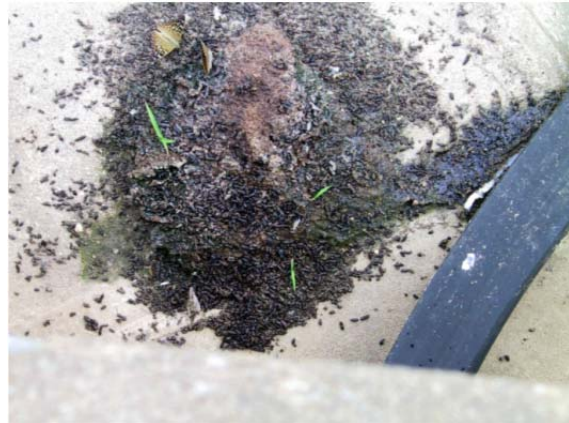
Photo 4: Guano deposits visible from bridge deck, on top of pier

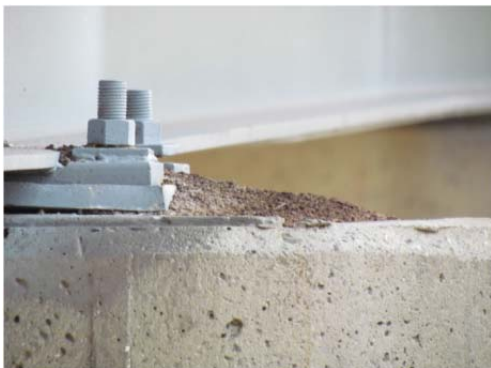
Photo 5: Guano deposit on pier, obscuring structural features.

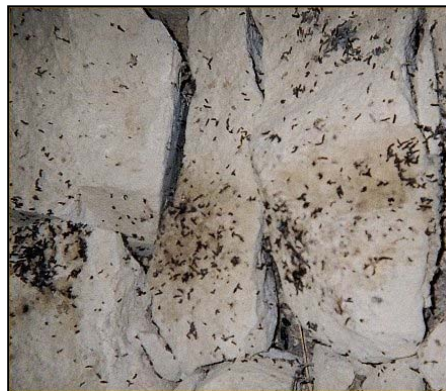
Photo 6: Bat Guano on Riprap

Bat droppings are small (mouse-like in appearance but less regular) brown or black pellets (Photos 6 - 8). Older droppings may be gray in color. These droppings will accumulate on the ground, floor of a covered bridge or on structural components below where bats roost.

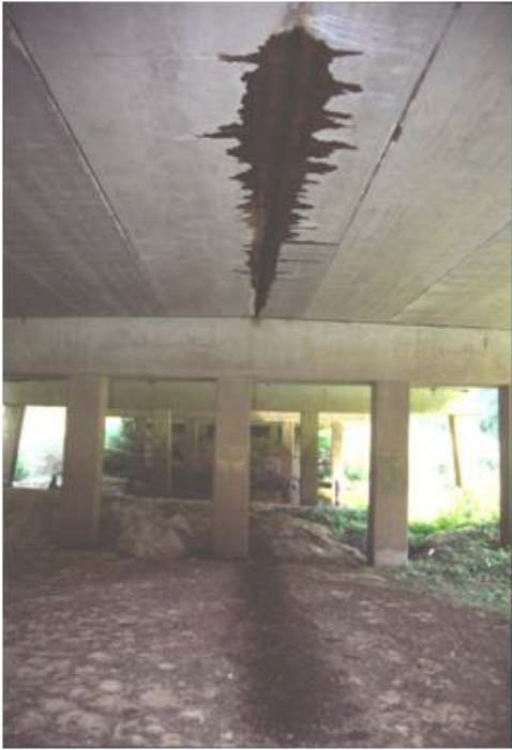
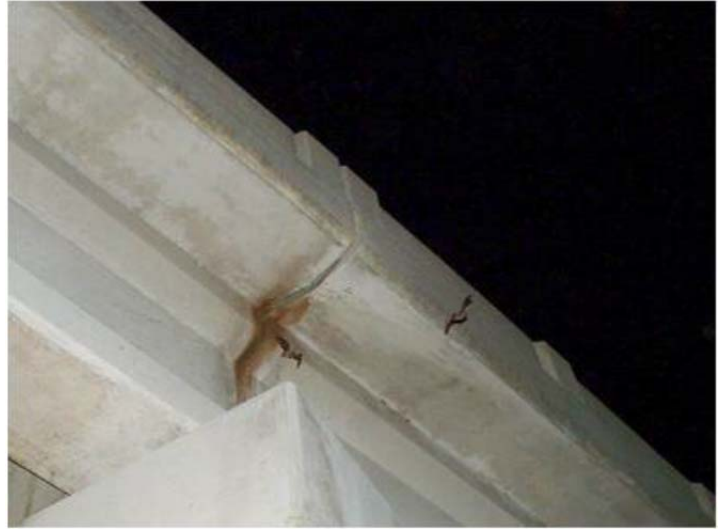
Photo 7: Staining along longitudinal joint. Note guano deposits on the ground. Photo 8: Staining on underside of expansion joint from bat use.

Stains may appear wet and are usually found in dark places. Look for four to six inch wide dark stains located on concrete support beams and walls immediately below the ceiling of the bridge, and beneath joints (Photos 8 - 11).

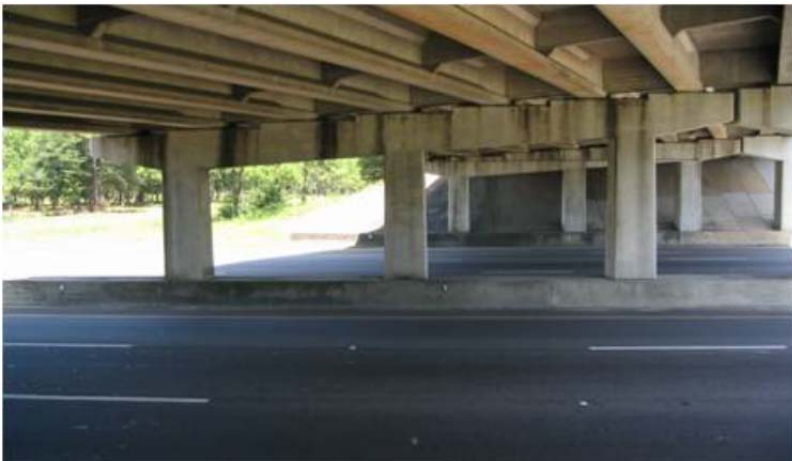
Photo 9: Staining on sides of pier caps

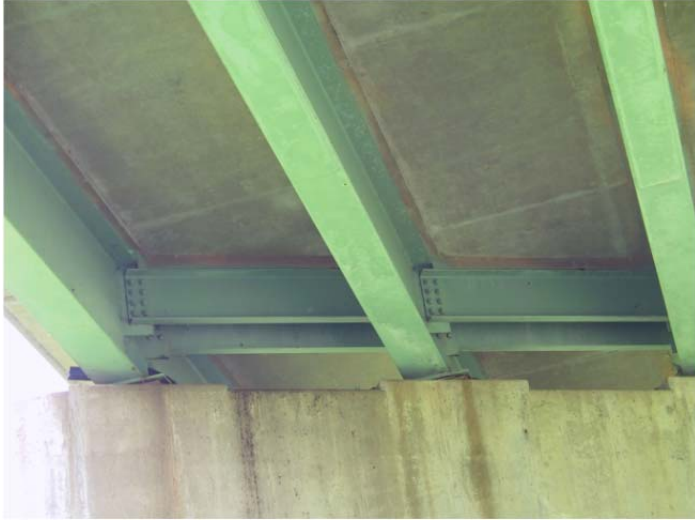
Photo 10: Guano staining on side of pier

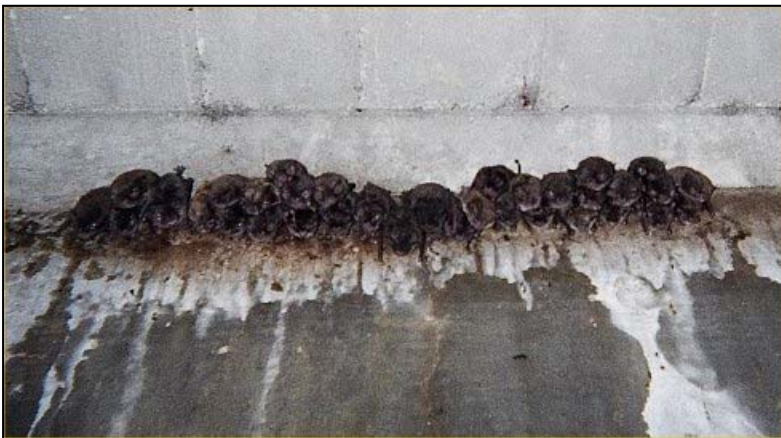
Photo 11: Bats Roosting & Associated Staining

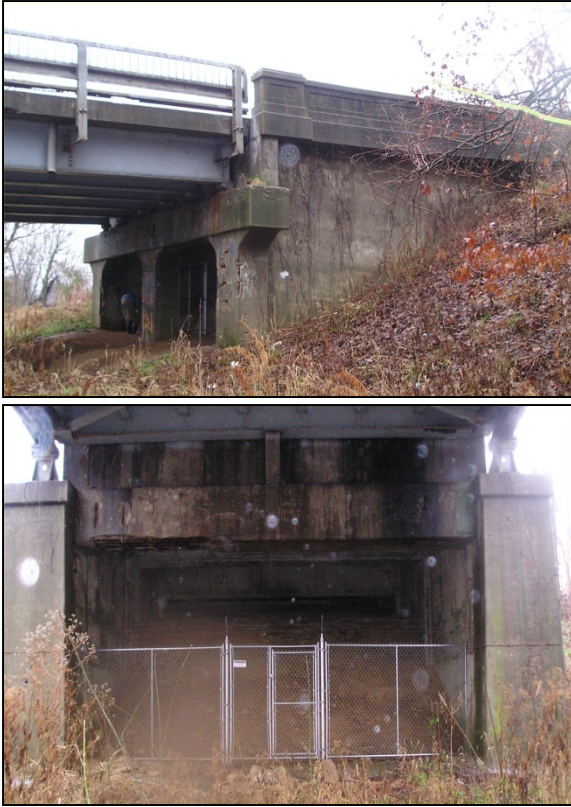
Photo 12 and 13: Bridge Design Mimicking “Cave-like” Atmosphere

While inspecting bridges or structures, look for dark environments that mimic cave-like conditions such as under the deck in the case of a bridge (Photos 12 and 13) or an attic in the case of a structure. This may involve crawling under low areas so a hard hat is recommended. Such places (e.g., a concrete bunker secreted into a hillside with an open front) provide protection from wind, rain, sleet, hail and predators. Bats do not roost near the ground where predators (cats, raccoons, etc.) can reach them. Roosting is usually at least 4 feet from the ground.

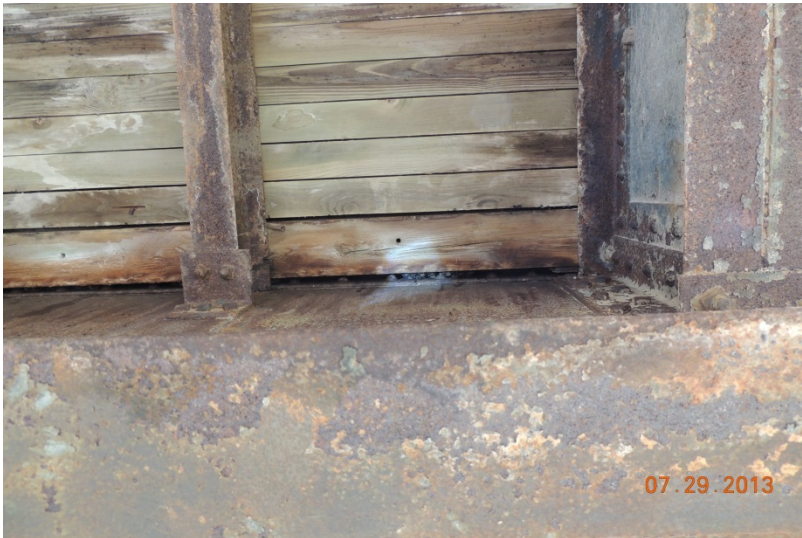
Photo 14: NLEBs Roosting Under a Timber Decked Bridge
